ASSIGNMENT

In accordance with your request, EFI Global, Inc. (EFI) has completed an engineering examination at the subject property located at the above loss location.

- Determine if the structure was damaged by hydrostatic and/or hydrodynamic forces associated with the reported flood event, the extent of pre-existing damage, or if the damage was due to other causes.
- Determine the cause and origin of the reported wall cracks.

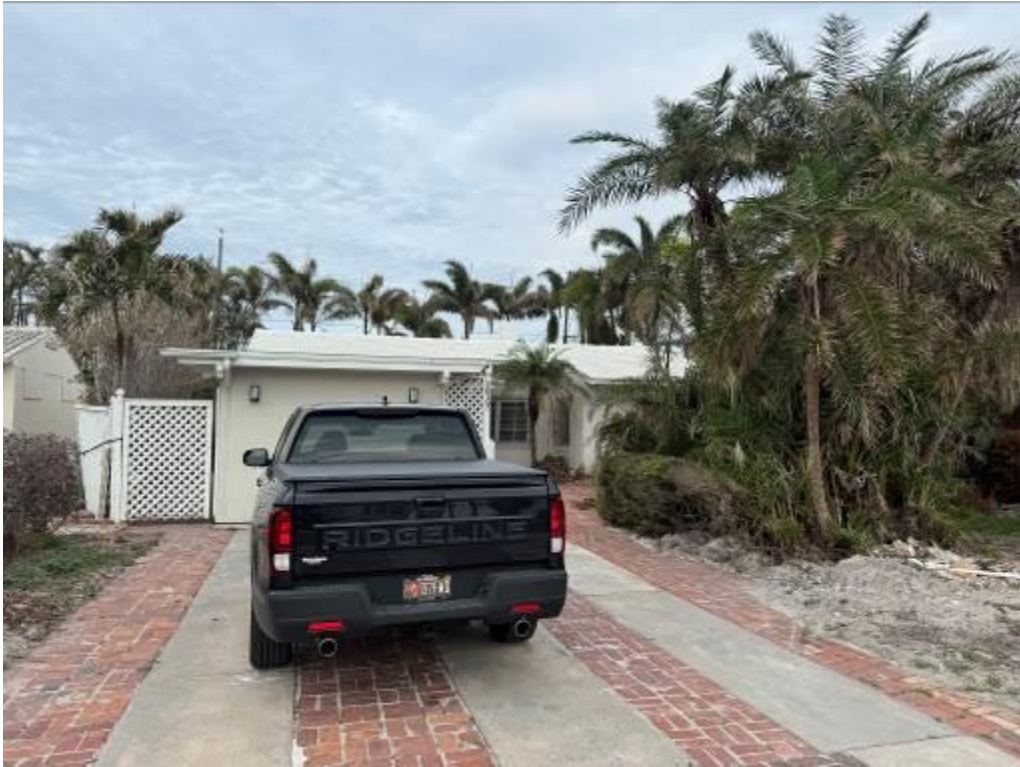
Photo No. 1: Front elevation.

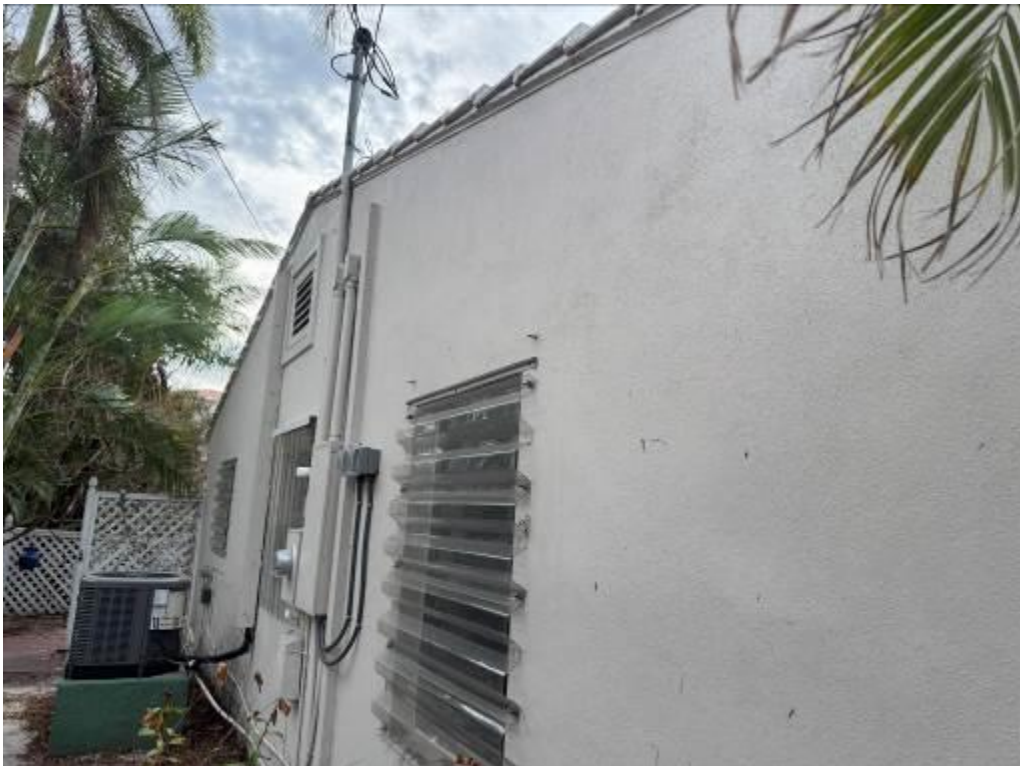
Photo No. 2: Right elevation.

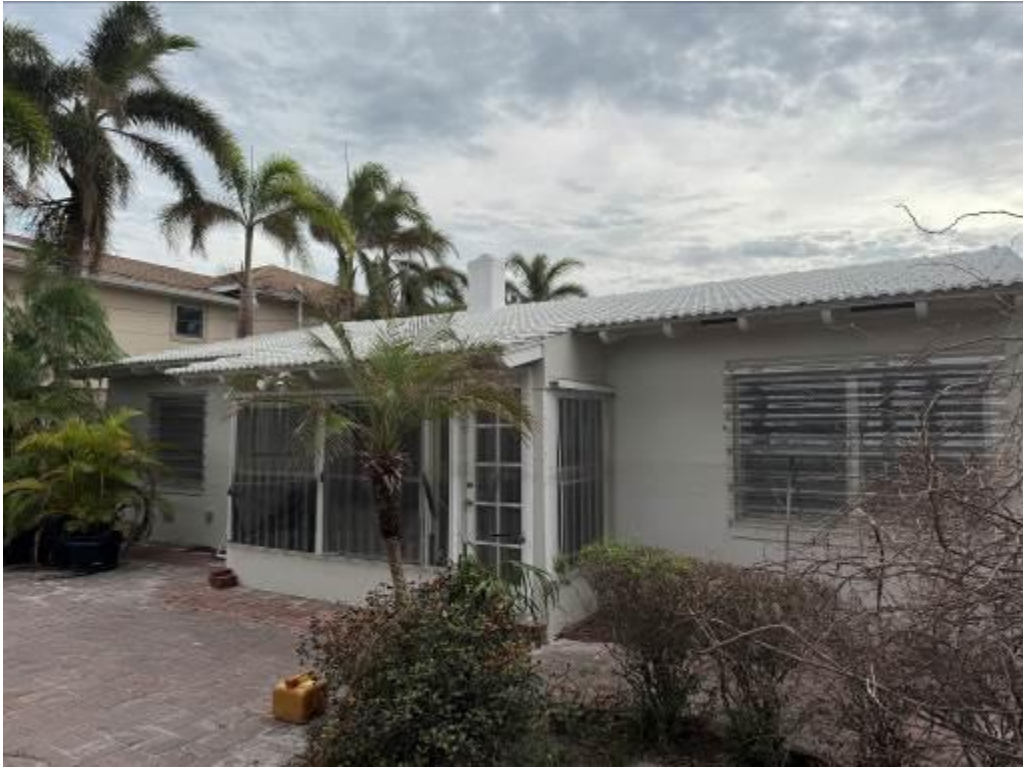
Photo No. 3: Rear elevation.

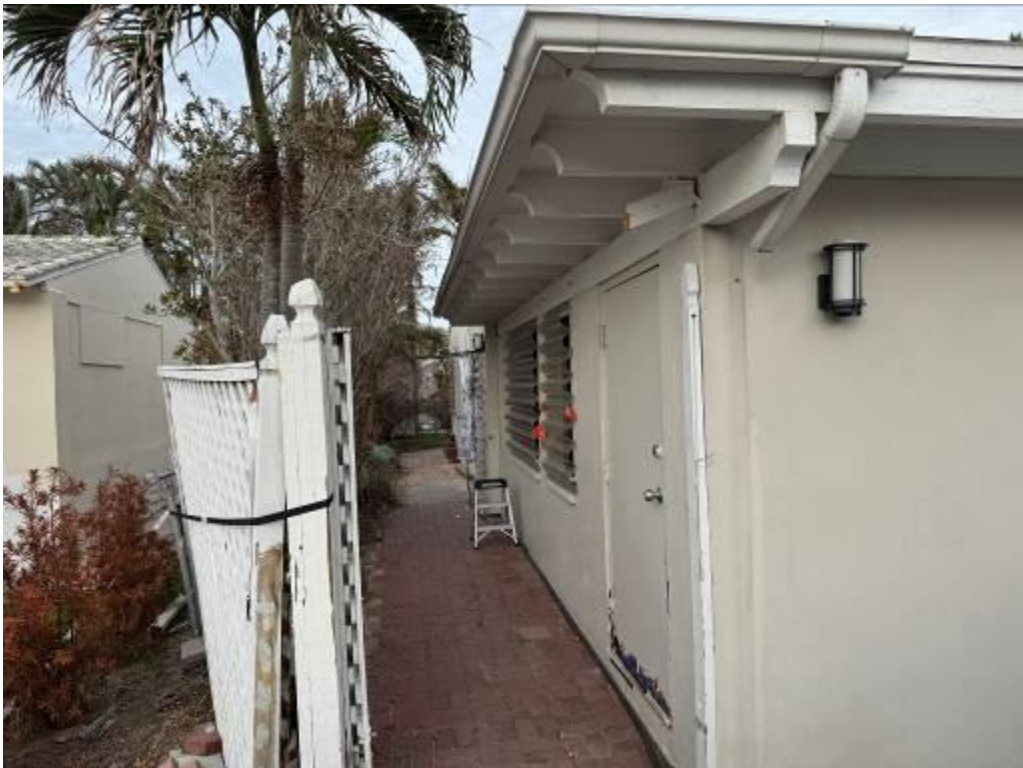
Photo No. 4: Left elevation.

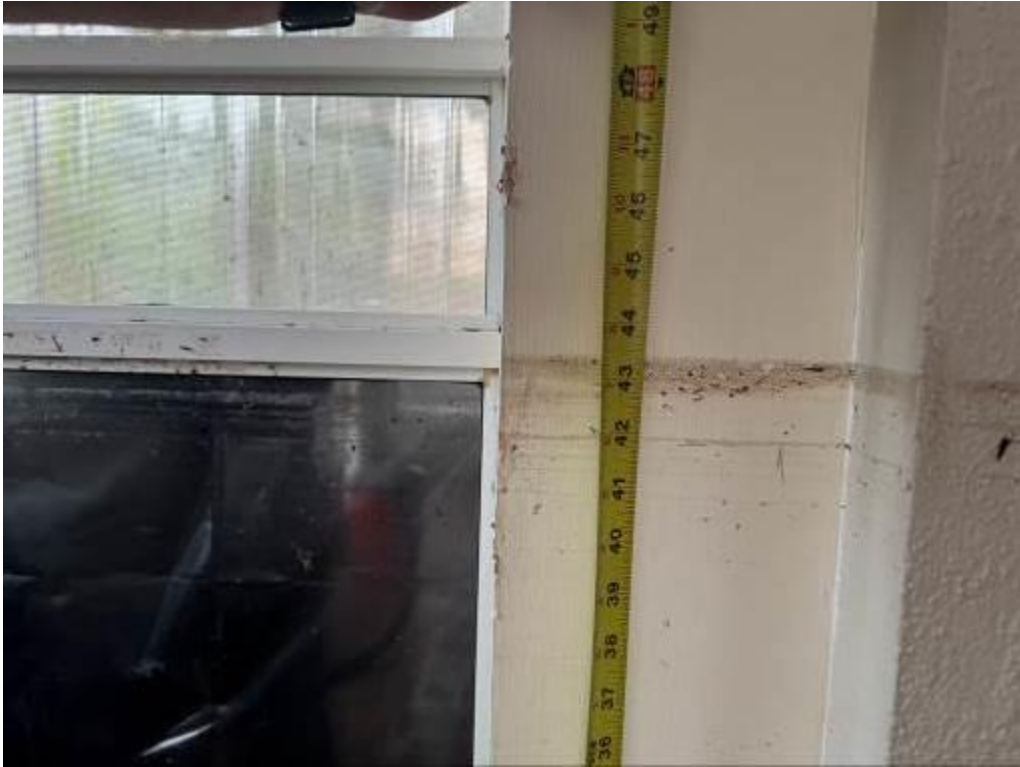
- A water line was observed at approximately 43-inches within the residence (Photograph 5).
- The lower portions of the drywall were removed prior to our evaluation (Photograph 6).
- No separations were observed along the wall-to-wall or wall-to-ceiling interfaces within the rear enclosed patio area (Photograph 7). A cracked/split door frame was observed (Photograph 8).
- Stucco cracking was observed along the roof-to-wall interface at the rear of the residence (Photograph 9). These occurred above the water level within the home.

Photo No. 5: Water line at approximately 43-inches within residence.

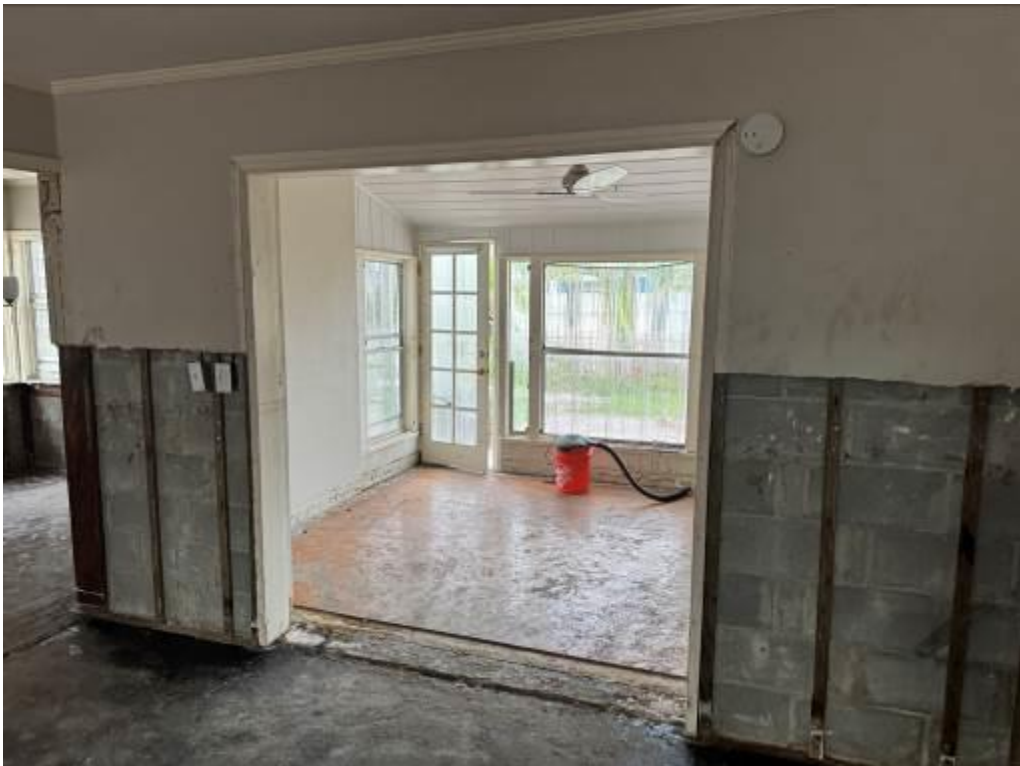
Photo No. 6: View of rear enclosed patio.

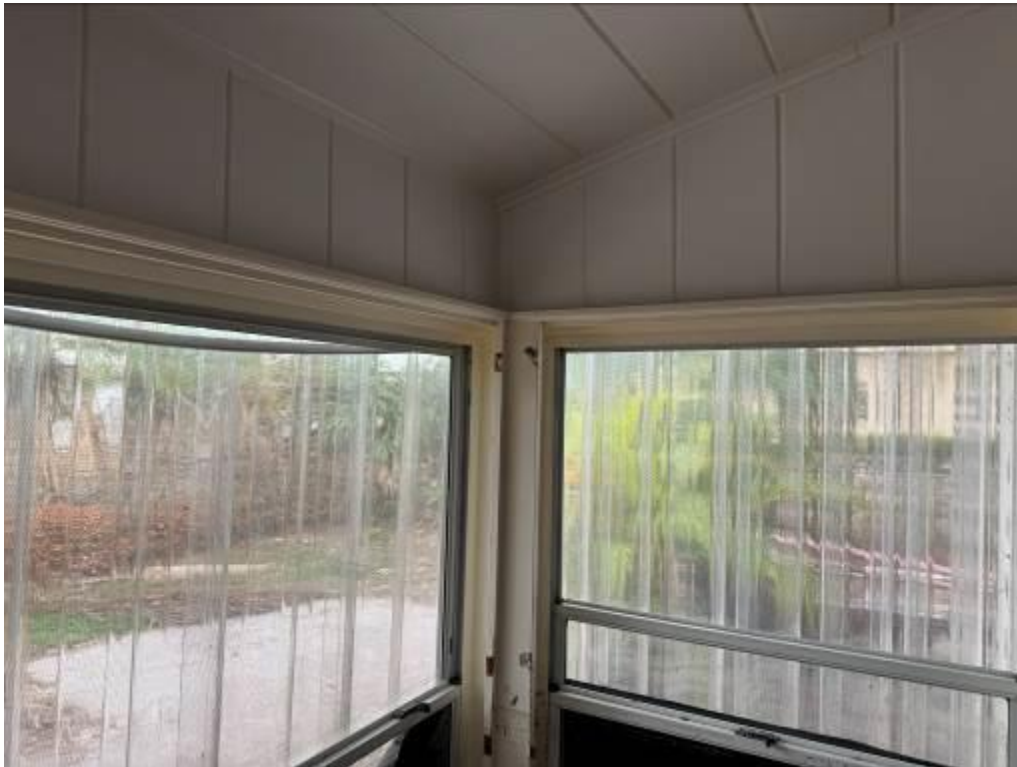
Photo No. 7: No separations along walls or ceilings within rear enclosed patio.

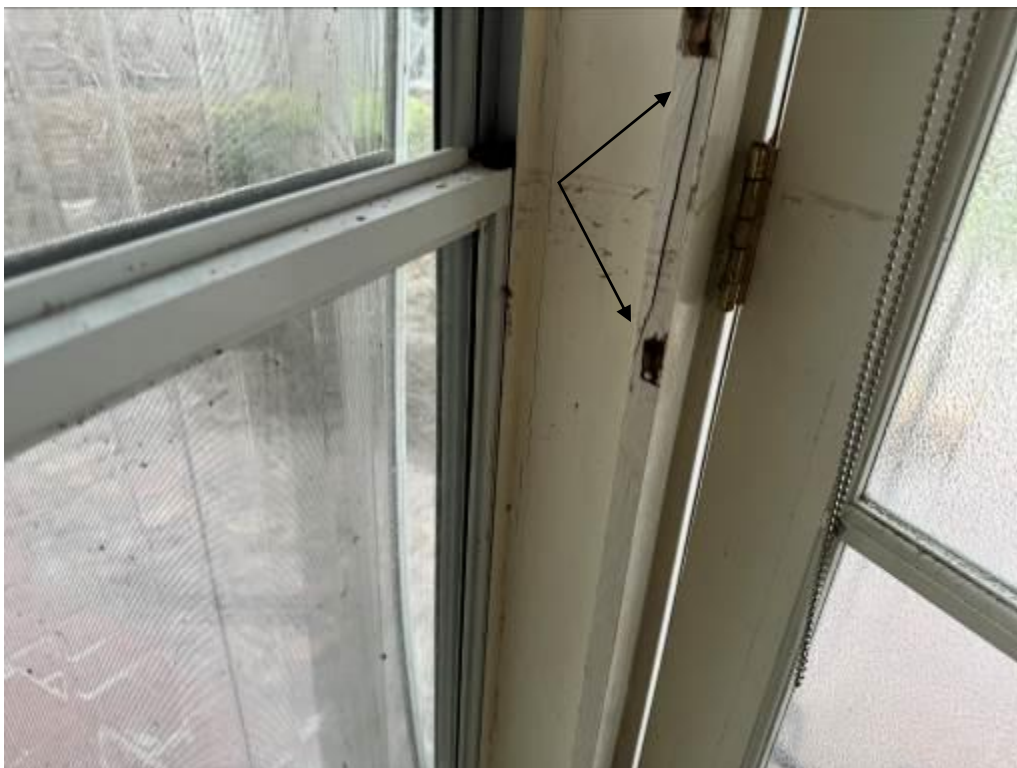
Photo No. 8: Cracked door frame in rear enclosed patio.

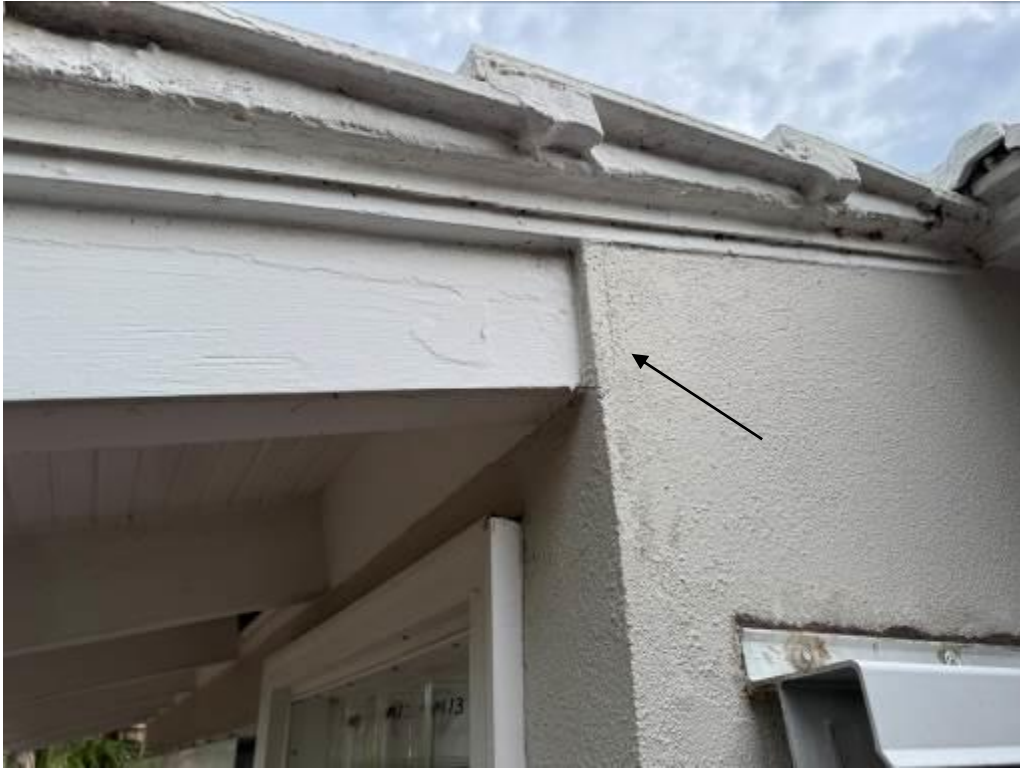
The stucco cracking observed to the residence is not consistent with resulting from a flooding event, as the cracking extends above the observed water level and located where stress concentration occurs along the roof-to-wall interface.

Photo No. 9: Stucco cracking along rear roof overhang.

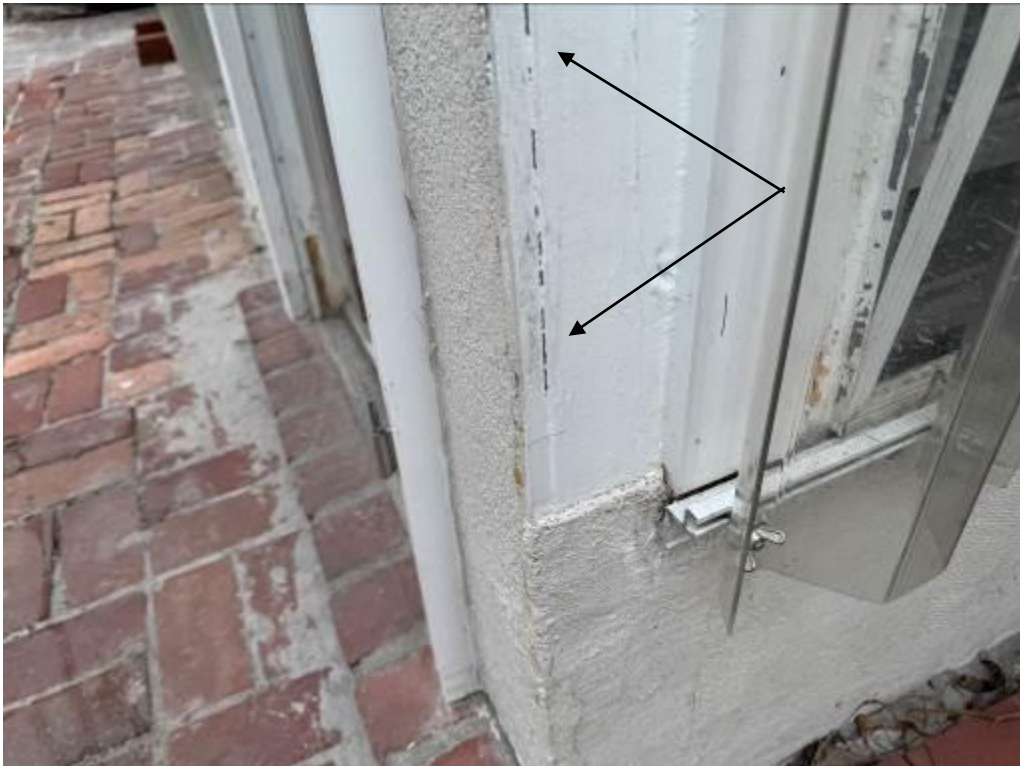
- Separations were noted within the rear patio column/support framing (Photographs 10 , 11, and 12).
- No listing/leaning of the structure was observed (Photograph 11).
- A vertical stucco crack was observed along the exterior perimeter of the home (Photograph 13).
- The site grading was generally flat adjacent to the structure.

The cracking/separations observed to the rear patio columns/framing is most consistent with long-term aging of the framing members. Construction materials exposed to elements deteriorate and crack due to fluctuation in temperature and moisture content. Water intrusion and corresponding swelling of the wood materials during the flooding event exacerbated this condition.

Photo No. 10: Reported cracking/separation at rear patio column/support framing.

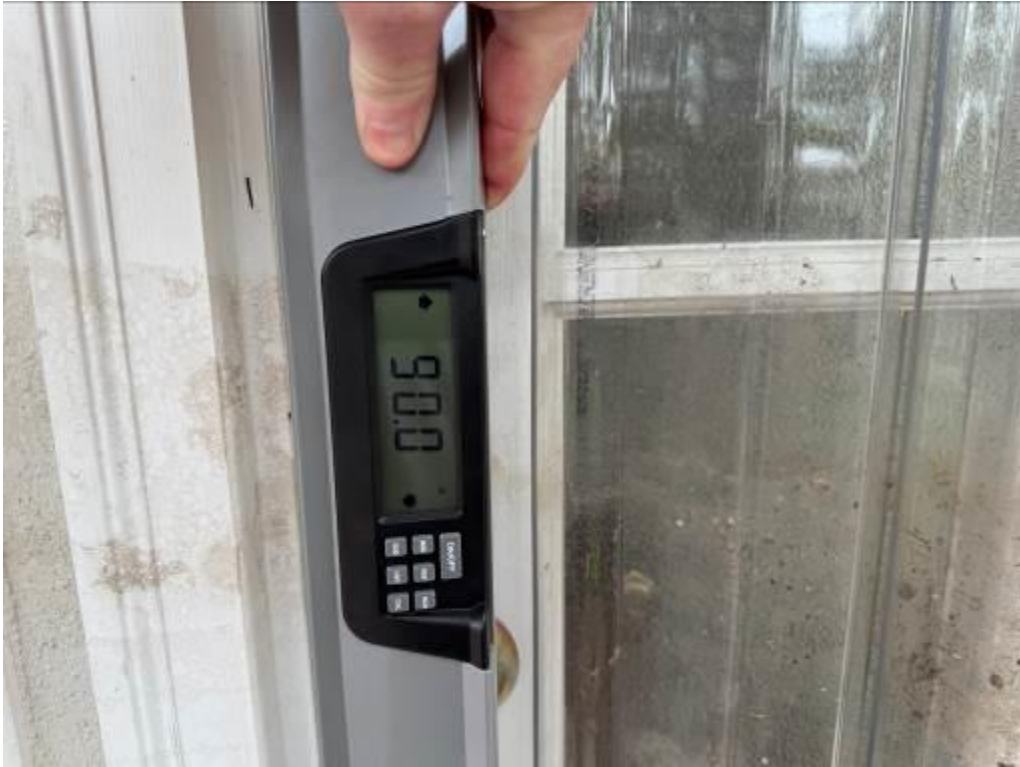
Photo No. 11: No listing/leaning observed to structure (typical).

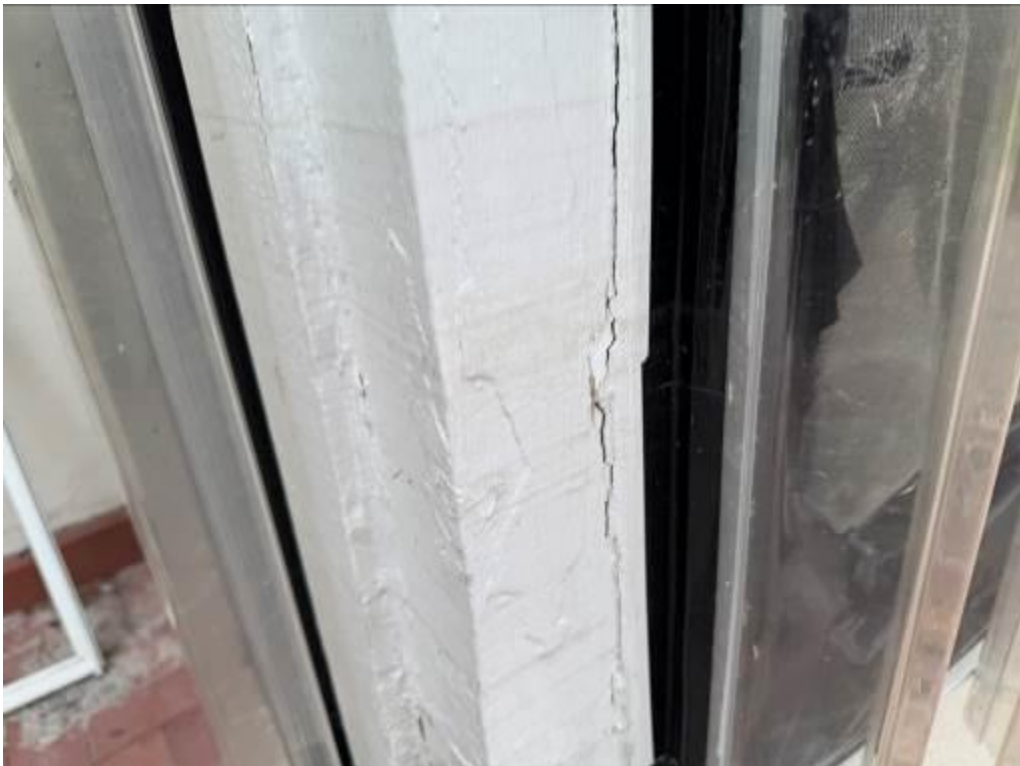
Photo No. 12: Cracking/separation of rear patio framing.

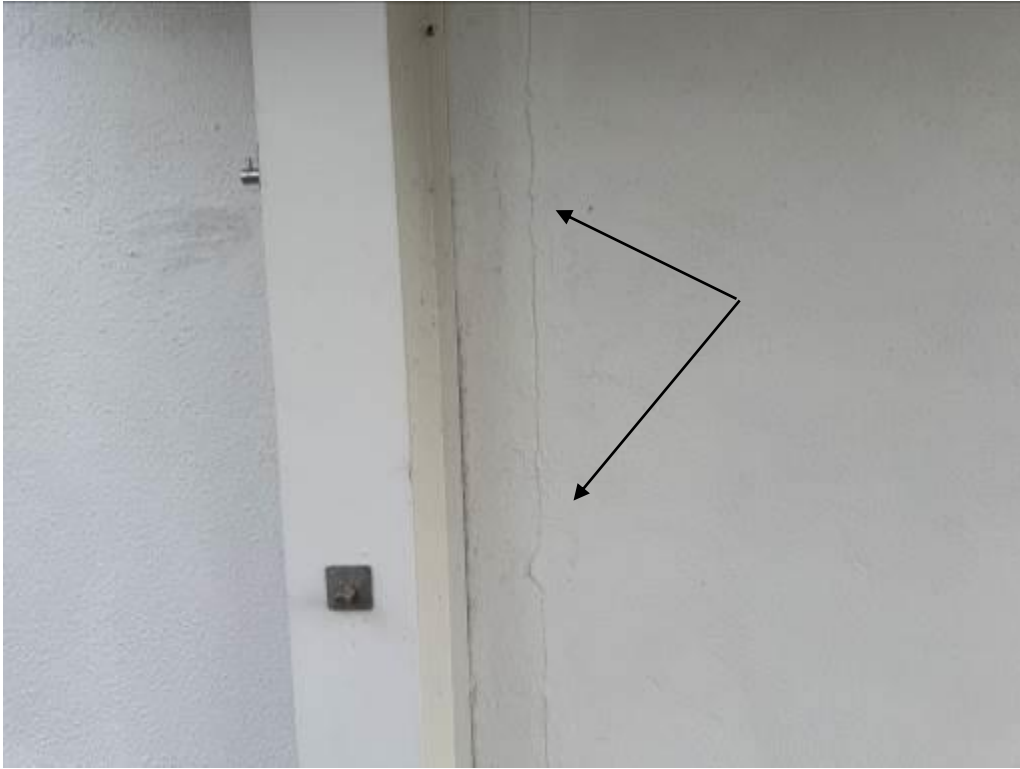
Photo No. 13: Vertical stucco crack.
